MITSUBISHI MOTOR SALES OF AMERICA, Inc.

TECHNICAL SERVICE BULLETIN

SUBJECT: **AUTOMATIC TRANSMISSION HYDRAULIC CIRCUIT — SERVICE MANUAL CORRECTION**

NO. TSB-91-23-006
DATE February, 1991
MODEL 1987-90 Van/Wagon, 1990 Montero

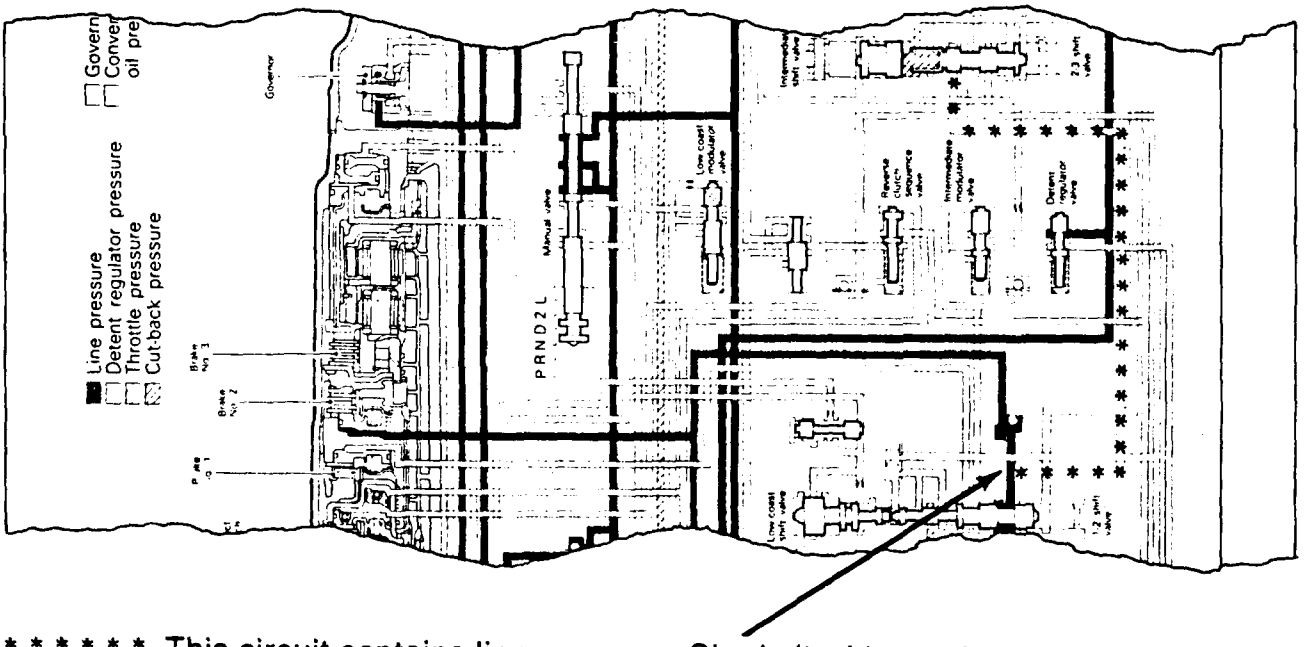
* * * * * * This circuit contains line pressure. Shade it with a red-colored pencil or pen to match the other line pressure circuits.
